## SITE INVESTIGATION SUMMARY REPORT

Marvin's Market  
221 Colchester Road  
Essex Jct., Vermont

SMS Site #94-1636  
UST Facility #7144  
TSEC #94-137

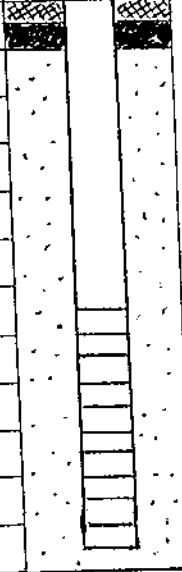
General soil conditions encountered at the SITE consisted of fine sand and gray silt. Groundwater was encountered at approximately 8 ft bgs. Contaminated soil was encountered during the installation of borings GPMW-101 and GPMW-103, both at depths of 11 ft bgs. A headspace analysis performed on these samples indicated VOCs present at a concentration of 17.0 parts-per-million volume (ppmv), and 180 ppmv respectively.

WATER LEVEL (APPROX)
8		<i>8-12'</i>			<i>- brown med sand (8-11').</i>	
9						
10		<i>11'</i>	<i>180'</i>		<i>- black petroleum staining &amp; odor, grey silt.</i>	
11						
12						
13						
14						
15						
16						
17						
18						
19						
20						
21						
22						
23						
24						
25
